DETERMINING OPTIMAL VERSION OF THE FILLER 1toFILL MONUMENTS, A SUSTAINABLE SUBSTITUTE FOR EPOXY FILLERS

Different versions of the vapour-permeable, water-proof, comprising only natural raw materials **filler 1toFILL Monuments**, which have been developed by the undersigned in 2013-2016, were subjected to a series of tests. Each test used an increased level of moisture impact, with the goal being to determine the optimal version of the filler.

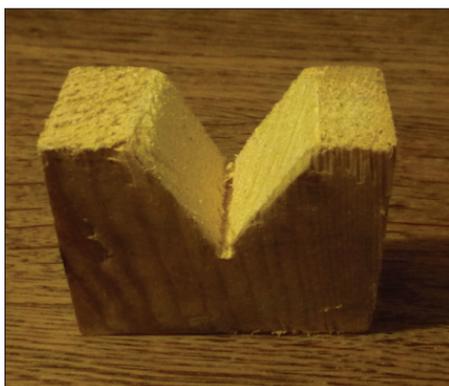
Test piece made from pine wood

Results for a standard test piece made from pine wood were as follows:

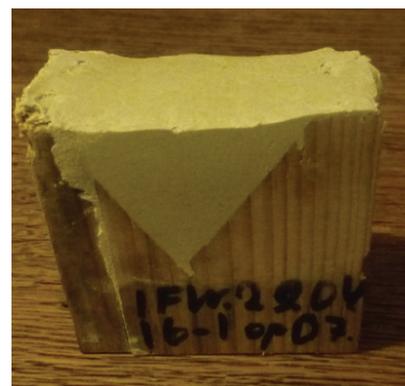
Test piece filled with 1toFILL Monuments

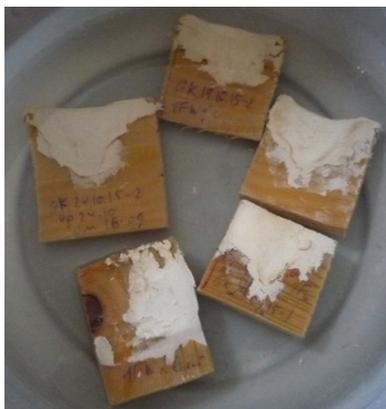
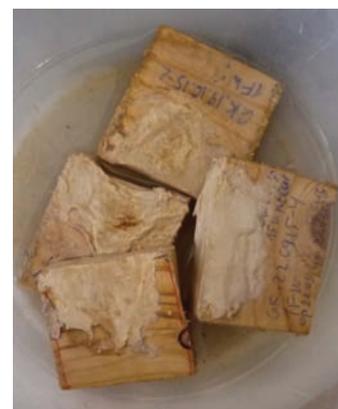
Test 1. Four test pieces were filled with four different versions of 1toFILL Monuments. After drying, these were left in their current state (i.e. not sanded down) and submerged for six months in a bowl of water. The test pieces remained fully intact, and there was no sign of destruction of the filler or detachment from the wood.

Test 1. 1st December 2015

Test 1. 20th April 2016

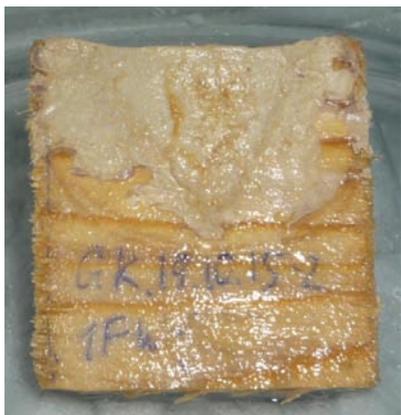
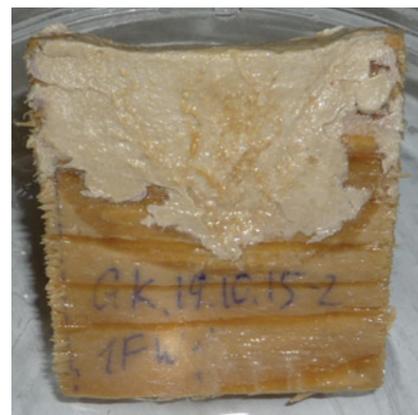
Test 2. One test piece was subjected to the freeze-thaw test. It was kept in a freezer for 20 hours every day at -4°C and for the remaining four hours submerged in water at 20°C , over a period of 30 days. The test piece remained fully intact.

Test 2. 23rd April 2016

Test 2. 21st May 2016

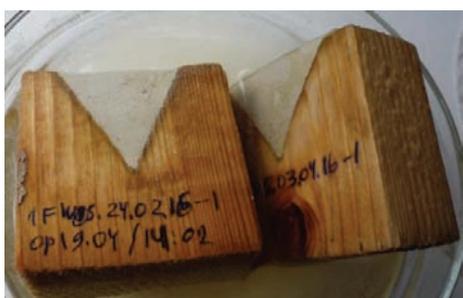
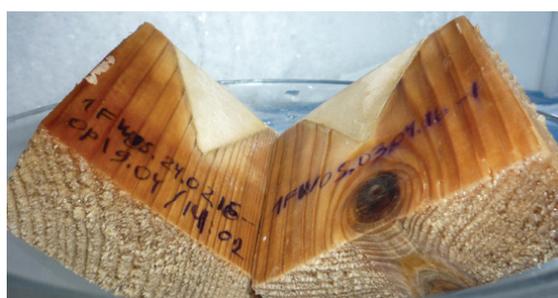
Test 3. The test pieces in Tests 1 and 2 were not sanded down, as doing so may weaken the filler's adhesion. In this test, two test pieces with two improved versions of 1toFILL Monuments were sanded down and subjected to the above freeze-thaw test for the period of 30 days. Both pieces remained fully intact.

Test 3. 25th April 2017

Test 3. 25th May 2016

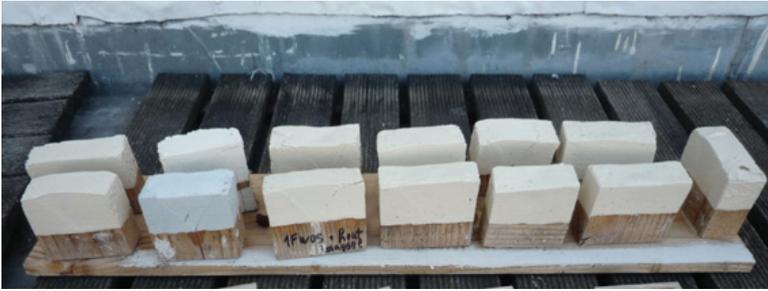
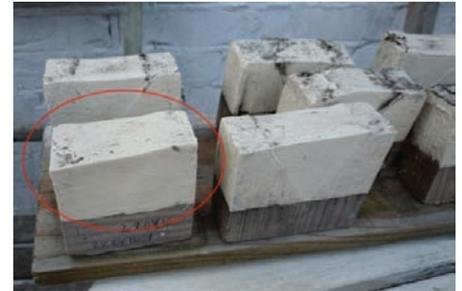
13 different versions 1toFILL Monuments, based on the version from Test 3, were used to fill 13 test pieces. These were sanded down and coated three times with highly vapour-permeable rectified linseed oil-based paint (Allback, Sweden). The bottom of each test piece was left uncoated to allow the moisture to penetrate into the test piece freely, resulting in significant impact upon both the timber and the filler. On June 22nd 2016, the cured test pieces were placed outdoors. After 7.5 months, 12 of the 13 pieces showed partial detachment of the filler and growth of fungi/mould along the cracks.

The exception was the test piece, circled in red. See the photo's on the next page.

Test 4. 15th August 2016

Test 4. 15th Februari 2017

In conclusion, repairs made using this version of 1toFILL Monuments in a window frame or a door frame, painted with Allback linseed oil paint, will remain intact for many years (in a domestic setting, the moisture impact is much lower than in the current experiment).

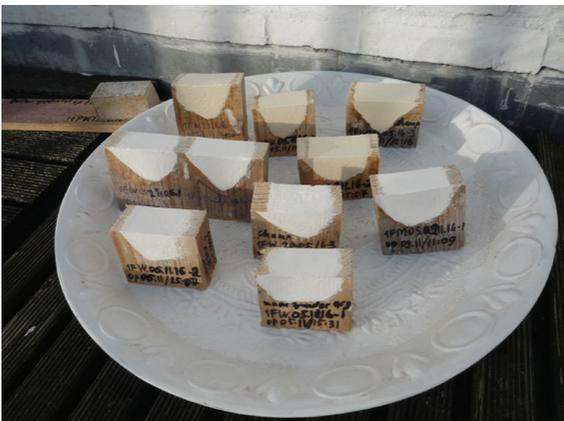
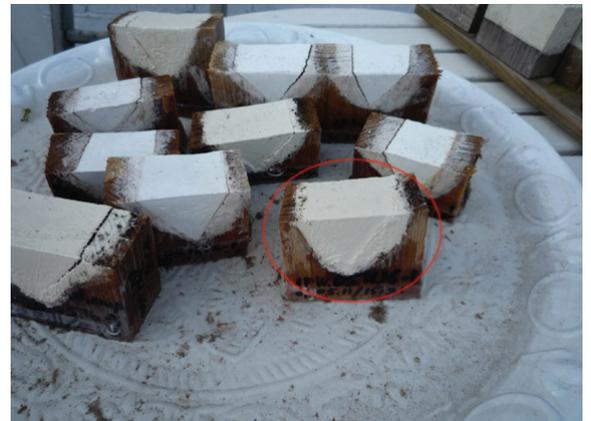
Test 5. To demonstrate the importance of the vapour permeability of the coating, we conducted a final test under even more extreme conditions. The new test pieces, one of which contained the successful combination from the previous test, and the rest containing variations of this version, were set on a tray and placed outdoors on November 30th 2016. Some of the test pieces were given three coats of vapour-permeable Allback linseed oil paint. Others were given three coats of completely vapour-impermeable paint. This was a rainy time of year, with night temperatures dipping below freezing. Within two days, the tray had filled up with water that did not have time to evaporate. The test pieces were therefore subject to an unusually high moisture exposure, as well as a natural freeze-thaw cycle. Again, the combination of 1toFILL Monuments and Allback linseed oil paint showed excellent stability, even after 2.5 months (see the test piece in the photo below, circled in red). The test pieces painted with the vapour-impermeable coating, however, began to show cracks by day three!

Test 5. 30th November 2016

Test 5. 15th Februari 2017

Conclusion: the more vapour permeable the coating/paint and the filler, the longer the “wood-filler-coating” will remain intact. The combination of 1toFILL Monuments + Allback linseed oil paint currently offers the best vapour permeability!
